Figure 3:  
Existing Conditions Map

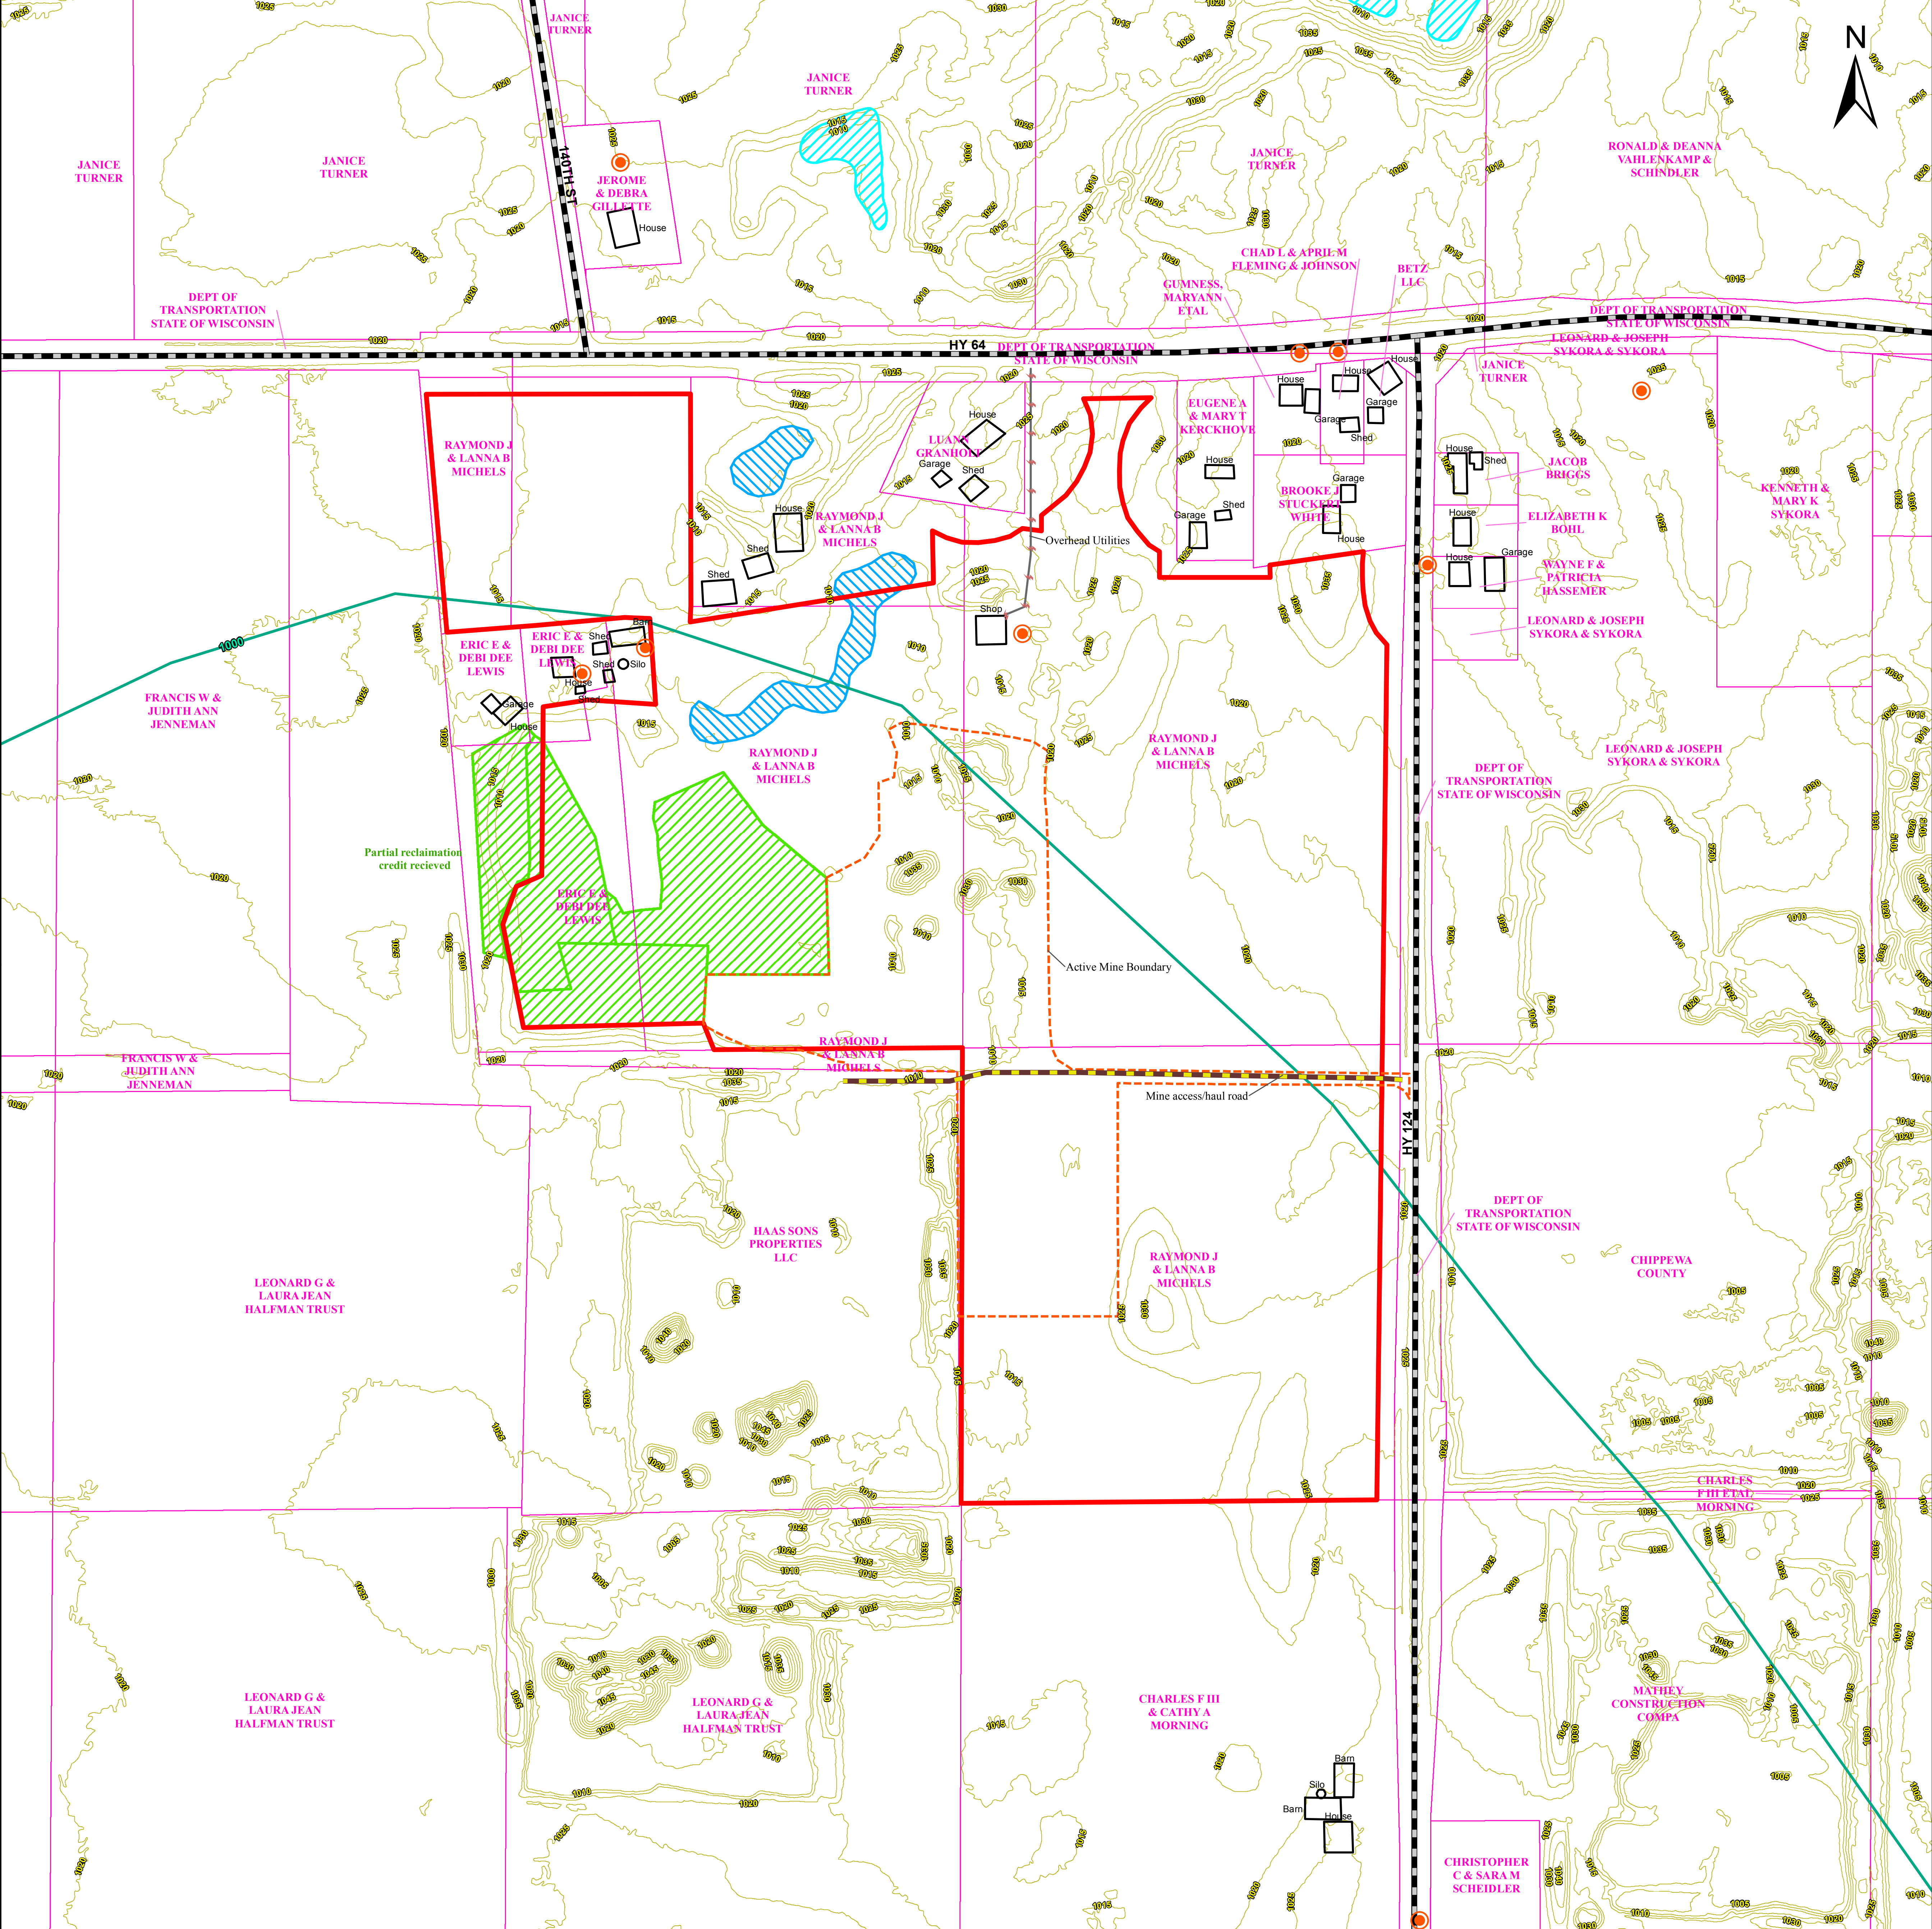
The reclaimed areas are officially reconized as partially reclaimed by Chippewa County LCFM.

5 foot contour intervals are from Chippewa County 2012 lidar dataset.

Water table contours are from Chippewa County groundwater elevations map. Groundwater elevation for the site is assumed to be 1000ft (above MSL).

There are no perennial or intermittent streams on site or within 660 feet.
